# Upper Longeron BAMF Simulation

**Brian Boeke**  
**A-10 Analysis**

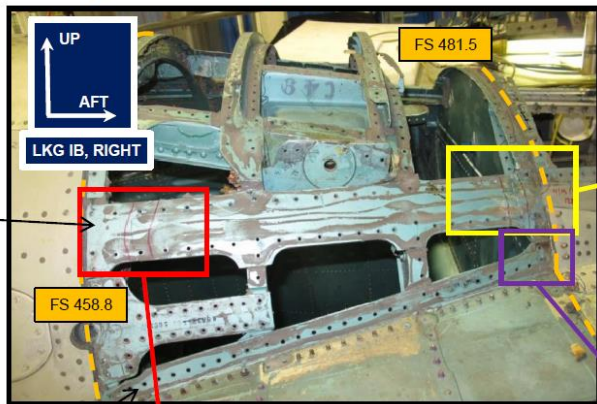
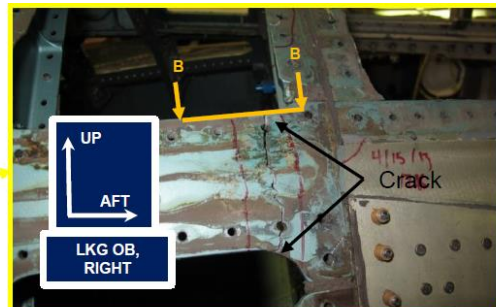
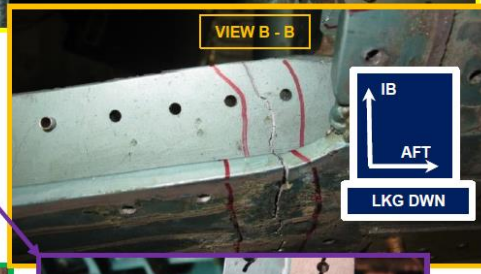
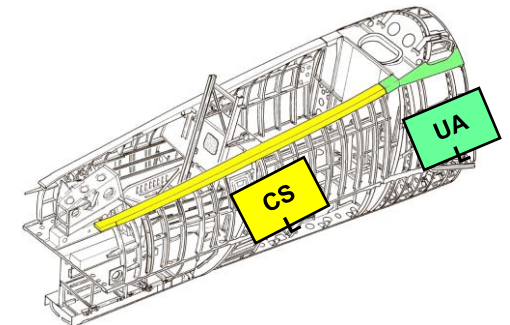
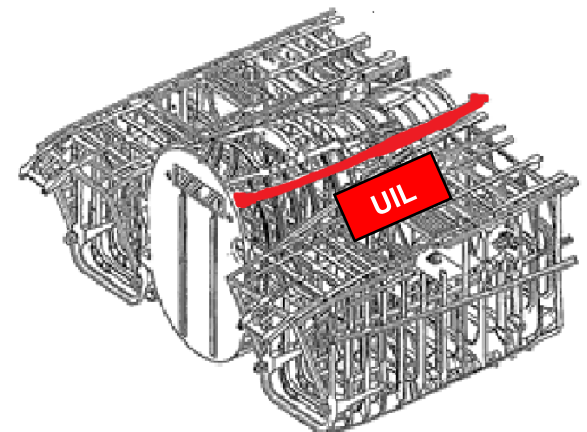
# Fatigue Test Failure

- During most recent fatigue testing, several failures were found, with UIL severed in multiple locations

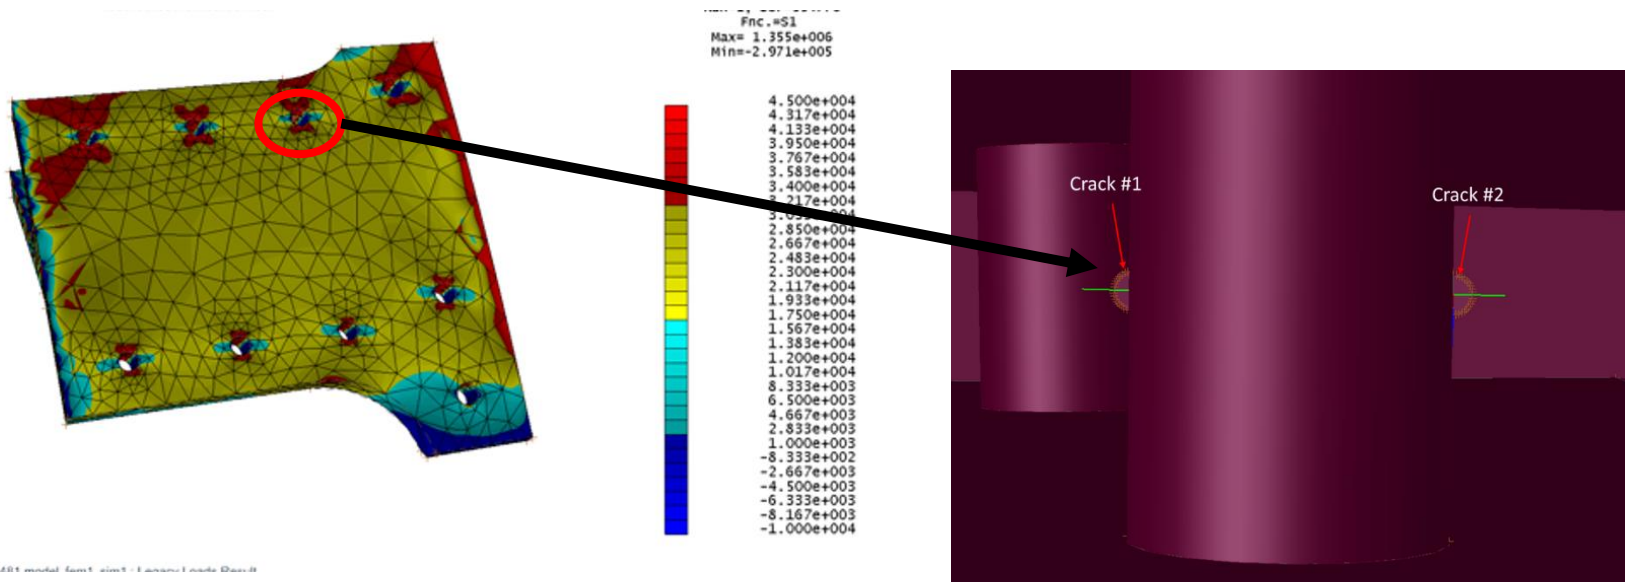
# Model

- Initial state was .01” radius semi-circular flaw at mid bore of critical hole
- Stress distribution from FEM results in NX
  - Adjusted to provide stress state that could produce failure

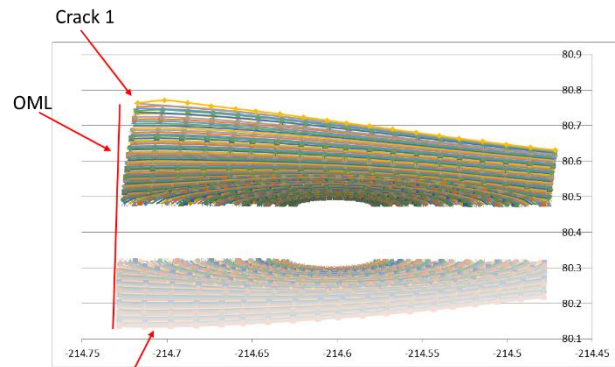
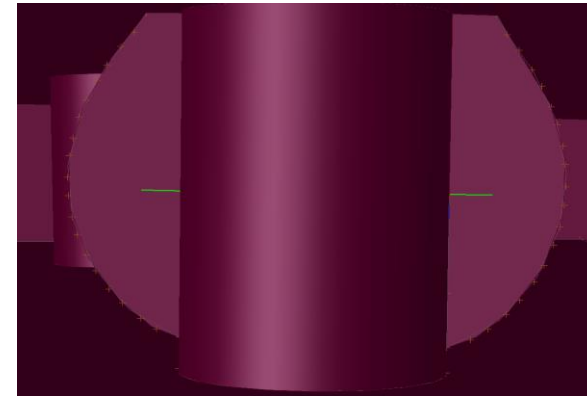
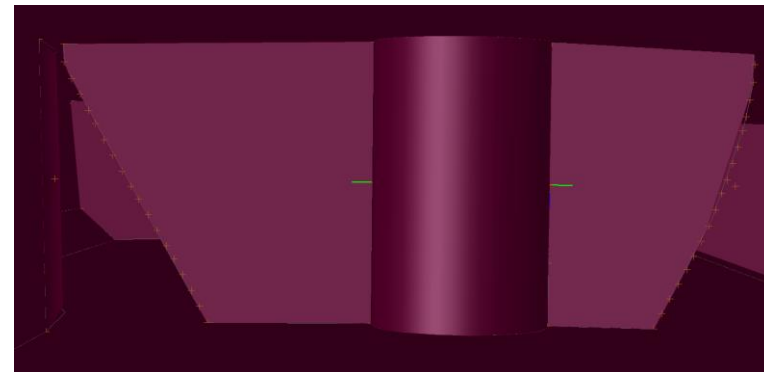
# Crack Evolution

Crack 2

- **BAMF model matched crack shape and life very closely (within a few hundred hours)**
- **Beta values for the crack mid point used for user-defined AFGROW model**
- **SOLR chosen for Generalized Willenborg retardation model provided good results and was within appropriate values for aluminum (~3)**
- **End result: BAMF results provided confidence in fracture mechanics model used to perform risk assessment**
